## Part B Fire - Inspections & Compliance

**NBC & MSO CPD – Building Control Inspections  
19<sup>th</sup> September 2023, Hodsen Bay Hotel, Athlone**

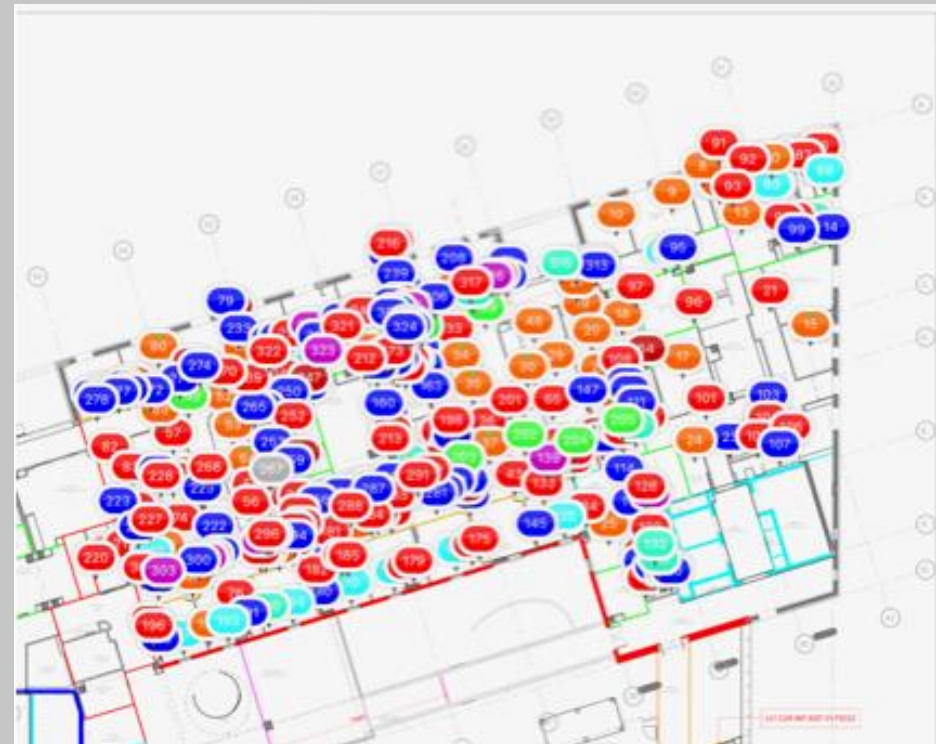
The screenshots attached demonstrate a typical inspection conducted within an area. The colour coding reflects different issues identified which are assigned to the contractor to address.

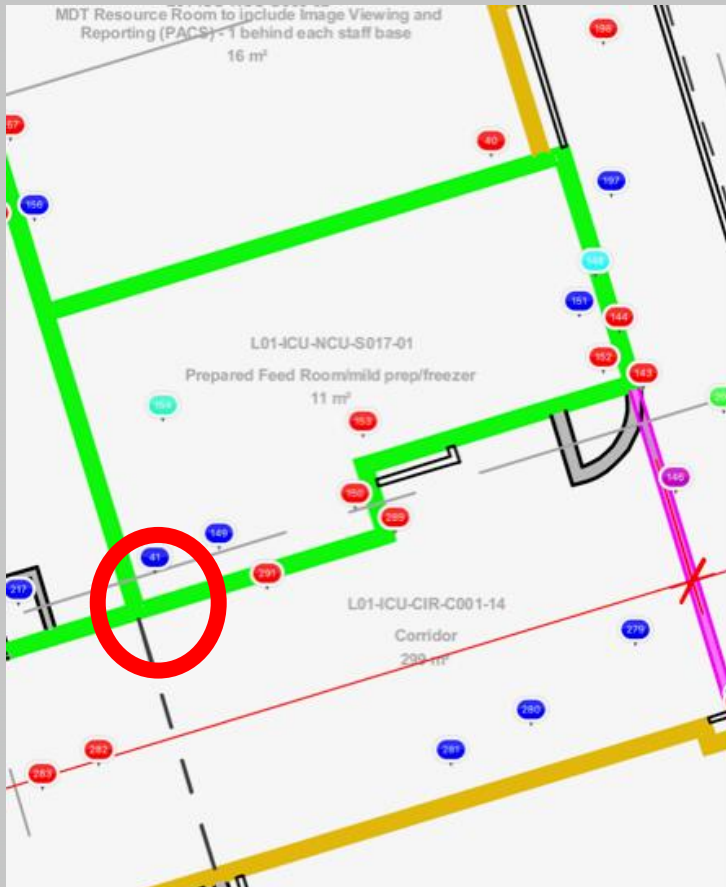
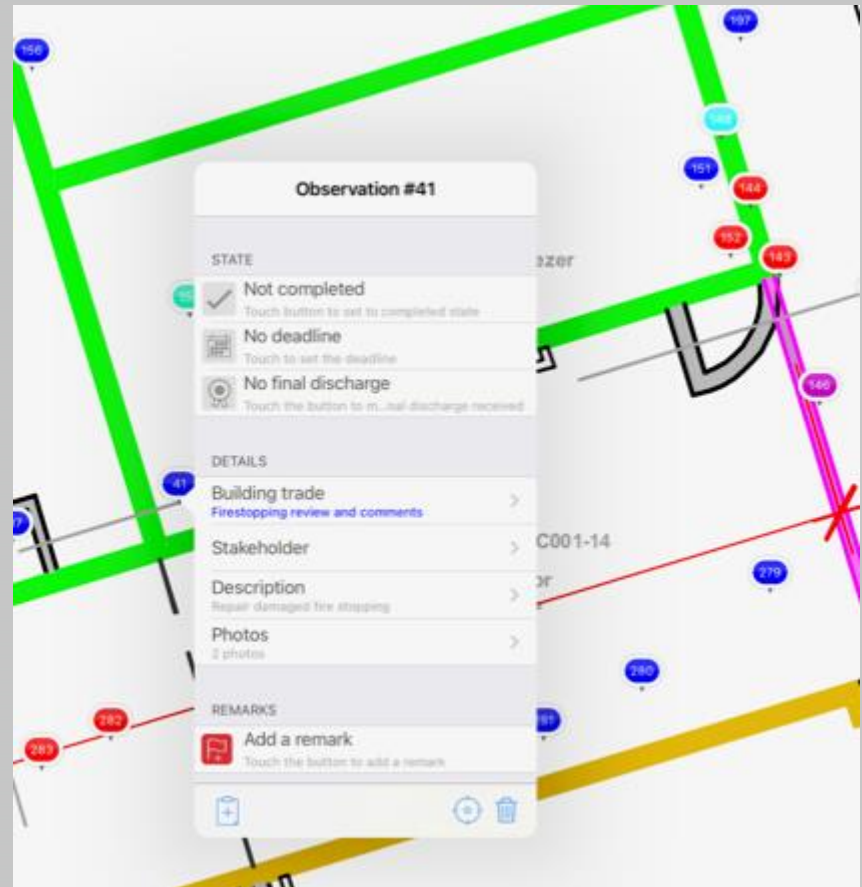
Example of a typical inspection issue identified. Take Tag 41 highlighted – firestopping damaged

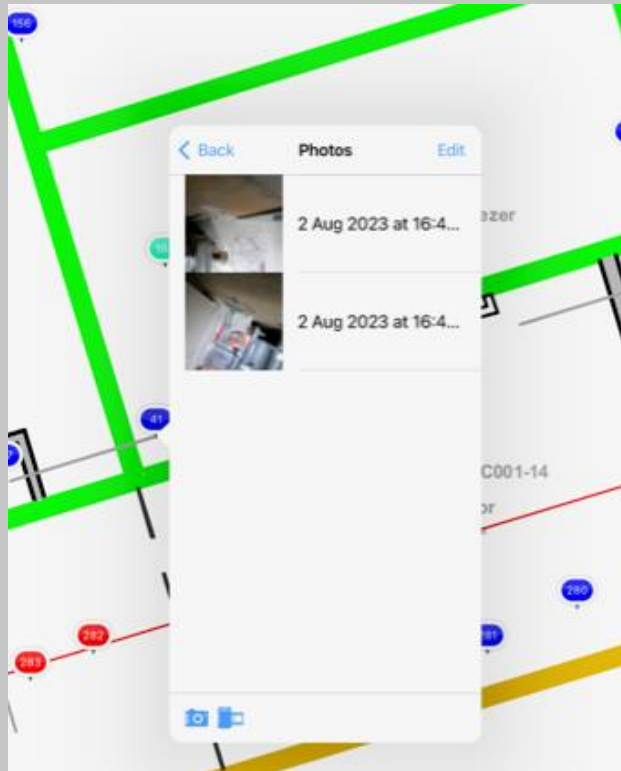
1. The Pin identifies the location.
2. The photos and the description identify the defect issue and what needs to be addressed.
3. This is then issued to the contractor to address who is then responsible for issuing to FCC a confirmation that the issue has been actioned and closed out.

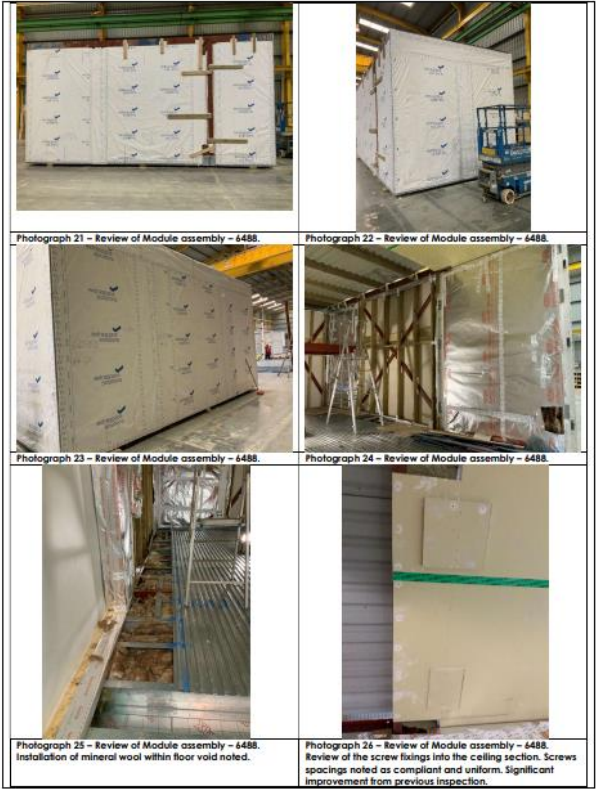
**Factory Inspection of a Modular construction used in a recent Healthcare Project**

- Depending on the Project requirements inspections may need to be conducted off-site
- The type of construction that is being employed on the project, such as **Modular Construction** would warrant inspection(s) being conducted at the factory where the construction is being assembled to check the standard of constructions/Quality etc
- Some of the construction elements, such as the application of intumescent coatings, may also be conducted off site so there will be a need to inspect these facilities to check the quality of the work/records etc.
- Records of these Inspections will also need to be kept by the Inspector/Ancillary Certifier
